**DEPARTMENT OF TRANSPORTATION**

Contract #: 04-0120F4Cty: SF/ALA Rte: 80 PM: 13.2/13.9File #: 69.28**WELDING INSPECTION REPORT****Resident Engineer:**Pursell, Gary**Address:** 333 Burma Road**City:** Oakland, CA 94607**Report No:** WIR-004603**Date Inspected:** 12-Oct-2008**Project Name:** SAS Superstructure**OSM Arrival Time:** 700**Prime Contractor:** American Bridge/Fluor Enterprises, a JV**OSM Departure Time:** 1700**Contractor:** Zhenhua Port Machinery Company, Ltd (ZPMC), Changxing Island **Location:** Shanghai, China**CWI Name:** Sun Wei**CWI Present:** Yes No**Inspected CWI report:** Yes No N/A**Rod Oven in Use:** Yes No N/A**Electrode to specification:** Yes No N/A**Weld Procedures Followed:** Yes No N/A**Qualified Welders:** Yes No N/A**Verified Joint Fit-up:** Yes No N/A**Approved Drawings:** Yes No N/A**Approved WPS:** Yes No N/A**Delayed / Cancelled:** Yes No N/A**Bridge No:** 34-0006**Component:** Tower**Summary of Items Observed:**

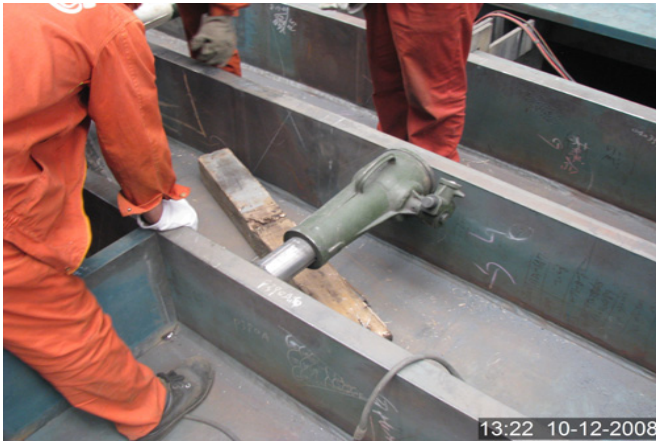
The Quality Assurance Inspector observed ZPMC performing fit-up and tack welding operations to the brace plate stiffeners between the longitudinal stiffeners. ZPMC was utilizing several ten ton jacks to aid in the fit-up. Please note the nondestructive testing was completed and accepted by ZPMC for the longitudinal stiffener to skin plate partial and complete joint penetration welds, where the jacks force is being applied. A digital photograph below illustrates the jacks.
